**REPORT NO. 03-20**

**TRANSPORTABILITY TESTING OF THE RAPID ISO BRACING  
SYSTEM (RIBS) IN A SIDE OPENING ISO CONTAINER OF  
BLU-109 (2,000 POUND) BOMBS,  
TP-94-01,  
"TRANSPORTABILITY TESTING PROCEDURES"**

Transportability Testing of the Rapid ISO Bracing System (RIBS) in a Side  
Opening ISO Container of BLU-109 (2,000 pound) Bombs,  
TP-94-01, Revision 1, July 2002 "Transportability Testing Procedures"

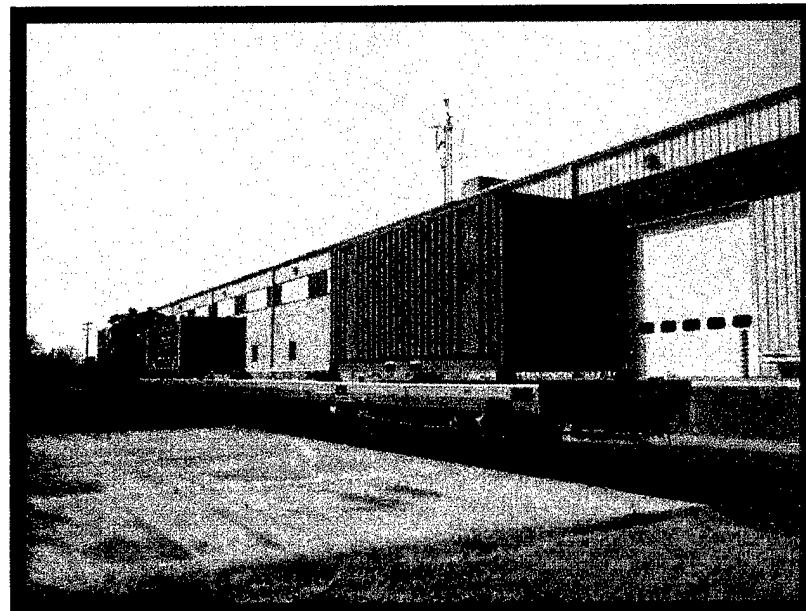
**Photo 6. Rail Impact Testing of Test Load (Prior to Testing)**

0-1.75 inches in the direction of impact; (c) The cradle assembly, on the non-door side, impact end, moved 1 inch in the direction of impact; (d) The main beams moved .5-.75 inches in the direction of impact; (e) The bomb pallets moved .5-.75 inches in the direction of impact; (f) The top corner cushion, on the non-impact end, on the non-door side of the container, loosened, but remained engaged; and, (g) The bottom corner cushion, on the non-impact end, on the non-door side of the container, disengaged and fell to the floor.

5. Following Impact #4: (a) The cradle assembly, on the door side, non-impact end, moved 1.25-2.5 inches in the direction of impact; (b) The cradle assembly, on the door side, impact end, moved 3-4.75 inches in the direction of impact; (c) The cradle assembly, on the non-door side, impact end, moved 1.5-2.5 inches in the direction of impact; (d) The center beams, moved .5-1.25 inches in the direction of impact; (e) The center corner cushion, on the non-door side, impact end, loosened, but remained engaged; and, (f) The tabs on the corner cushion to the bottom beam interface, on the non-door side, impact end, failed. The corner cushion was no longer attached to the beam.

6. The load still remained safely restrained and no visible damage occurred to the nose cones or beam buffer pieces.

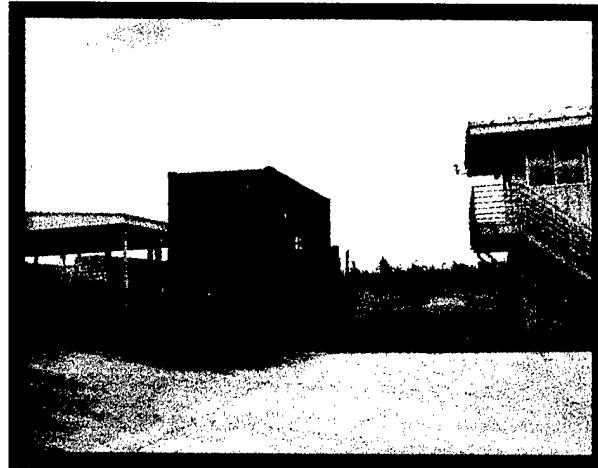
**Photo 9. Washboard Course Testing of the Load.**

1. Inspection following the completion of the washboard course revealed that the center beams had moved .75-2 inches toward the door of the container.
2. Four nose cones were loose but safely in place.
3. The load still remained safely restrained and no visible damage occurred to the nose cones or beam buffer pieces.

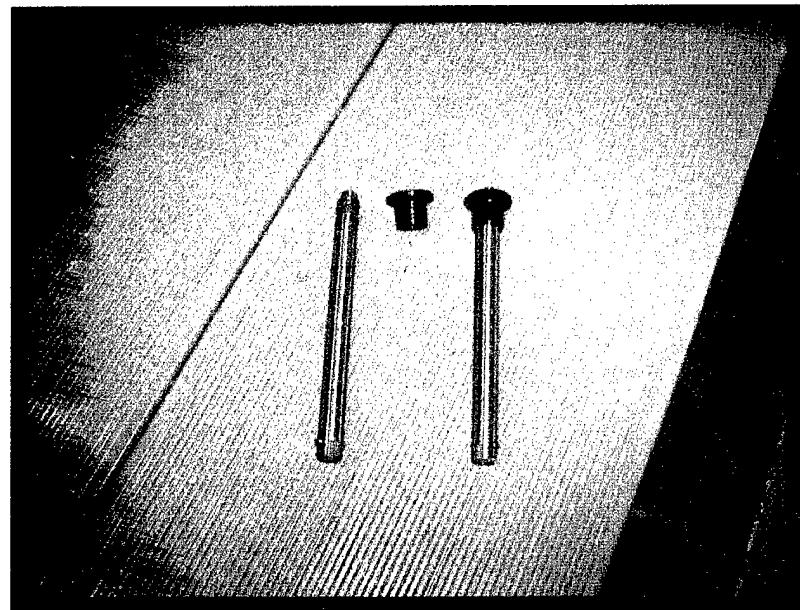
**Photo 10. Lock Pins.**

**E. FINAL INSPECTION.** Three vertical poles permanently deflected during testing. Additionally, when removing some of the cradle lock pins the finger holds on the pins pulled out. Inspection revealed that the finger holds were only glued in place and that the black finger holds were not properly threaded. Photo 10 shows a lock pin with the finger hold installed (right pin) and one pulled loose (left pin). The nylon straps and wire ties did adequately hold the beam buffers in place while the Velcro did not adequately hold the beam buffers in place. Also, caution must be used when loading/unloading the payload to prevent damaging the beam buffers and ties.
